## Robinson Helicopter Company Accident Report

AIRCRAFT MODEL:	<u>R44 Clipper I</u>
SERIAL NUMBER:	<u>1295</u>
REGISTRATION:	<u>N7530R</u>
ACCIDENT DATE:	<u>30 January 2018</u>
ACCIDENT LOCATION:	<u>Newport Beach, California</u>
NTSB IDENTIFICATION:	<u>WPR18FA077</u>

REPORT WRITTEN BY: Ken Martin

DATE: 17 June 2019

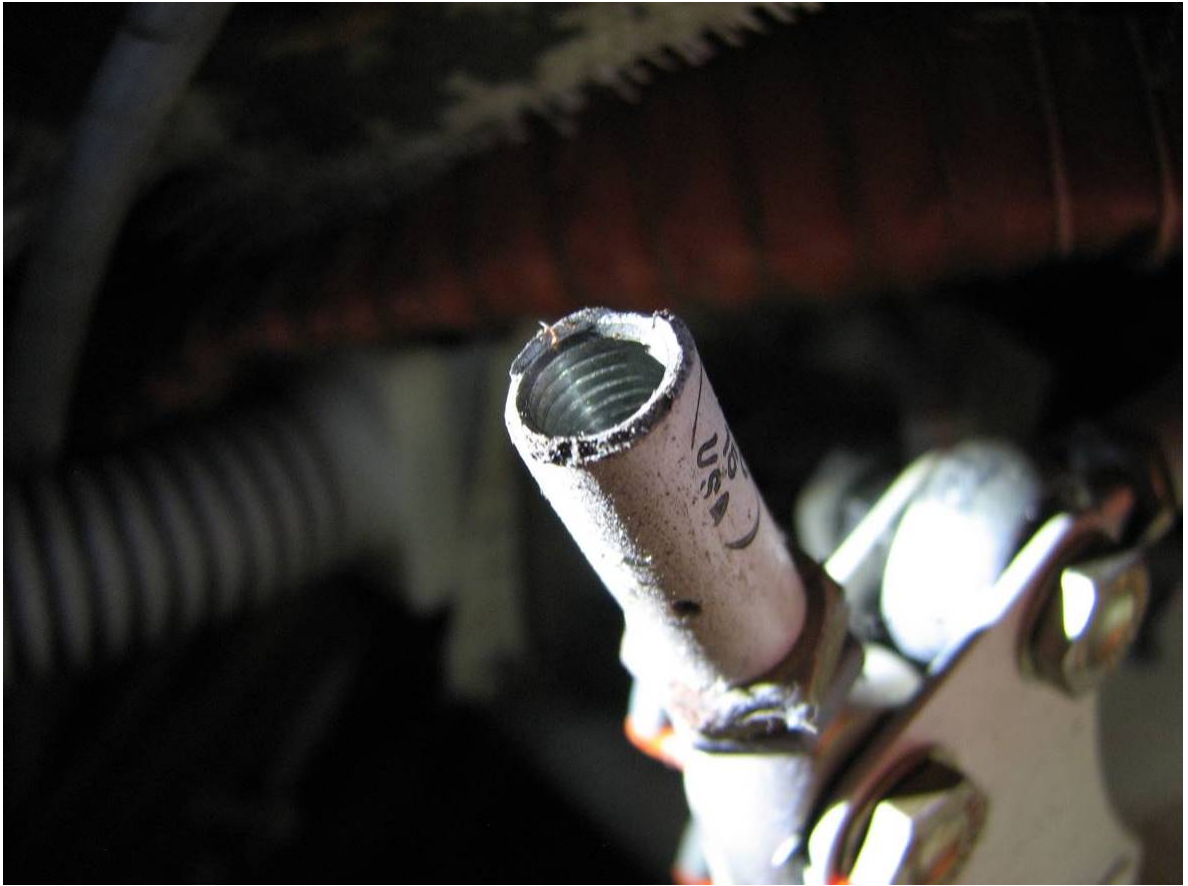
Disconnect TD in aft portion of the C343-11 push pull tube

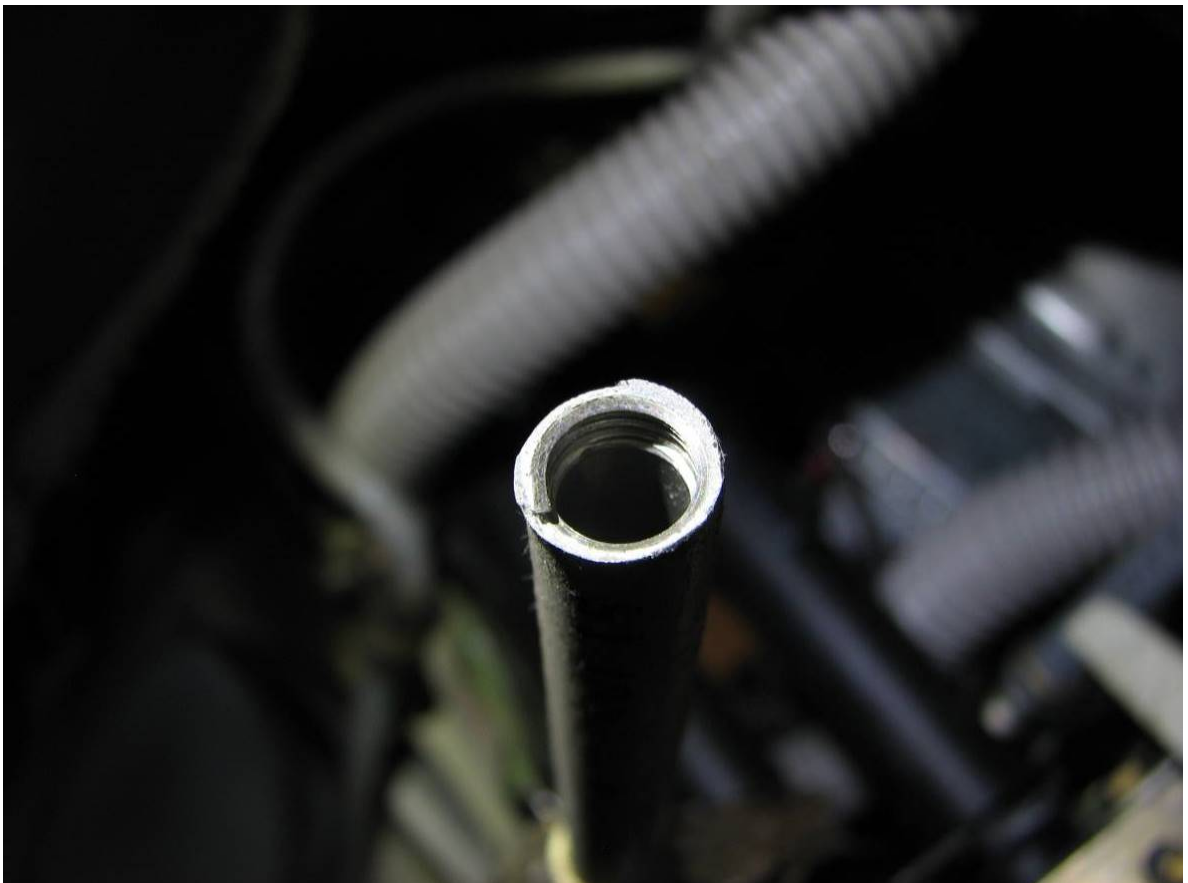
Disconnect TD in forward portion of the C343-11 push pull tube

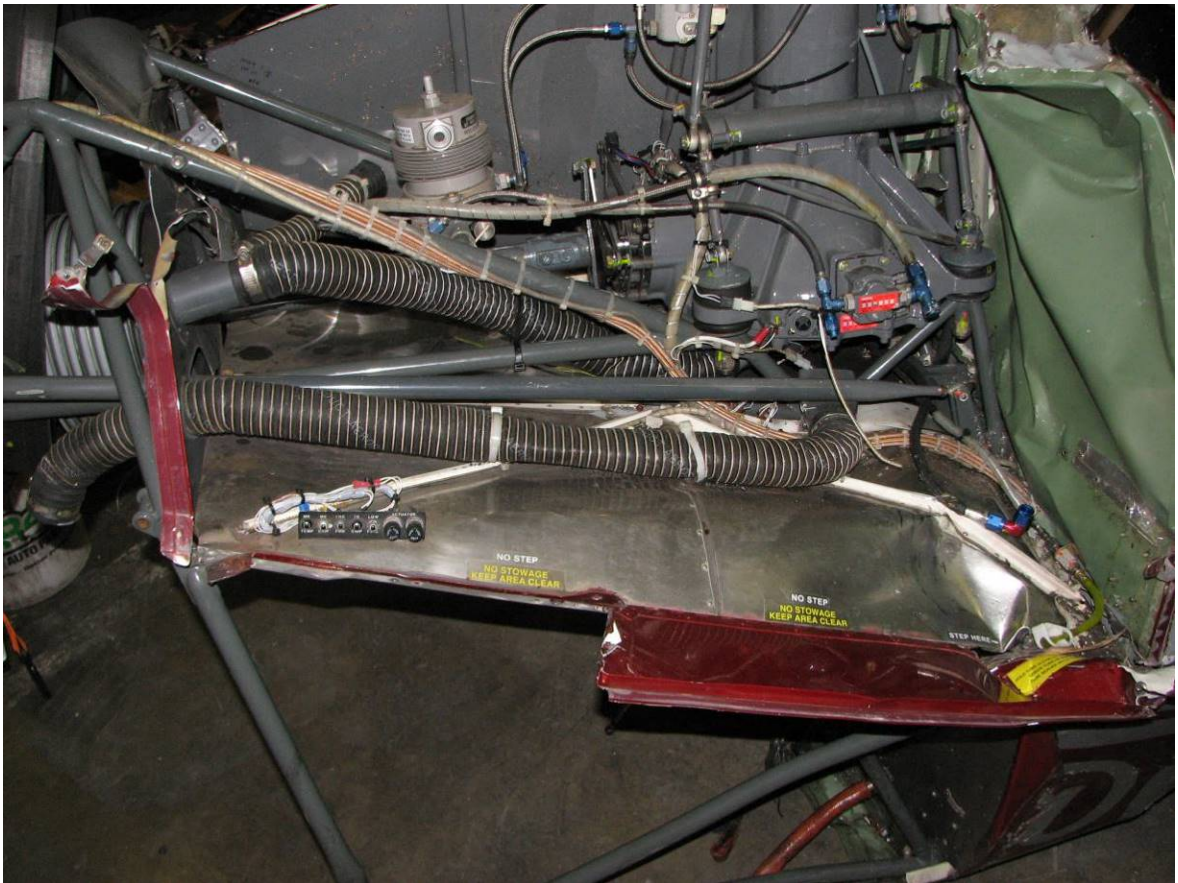
The horizontal firewall was distorted overall with more extensive damage at the forward edge. The cabin bulkhead was distorted and crushed downward mostly on the right side. The vertical firewall was distorted overall with more extensive upward crushing on the lower left side.

Damage to the horizontal firewall and cabin bulkhead

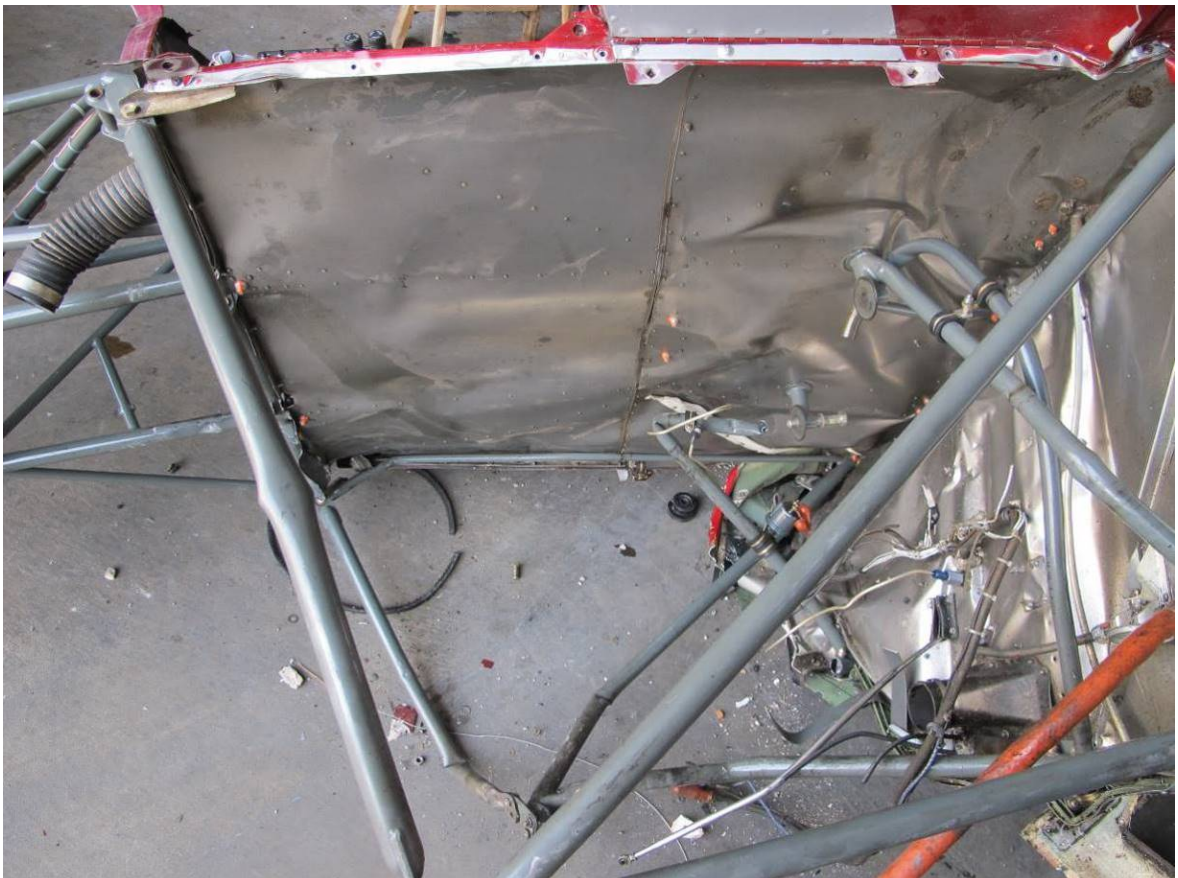
Damage to the horizontal firewall

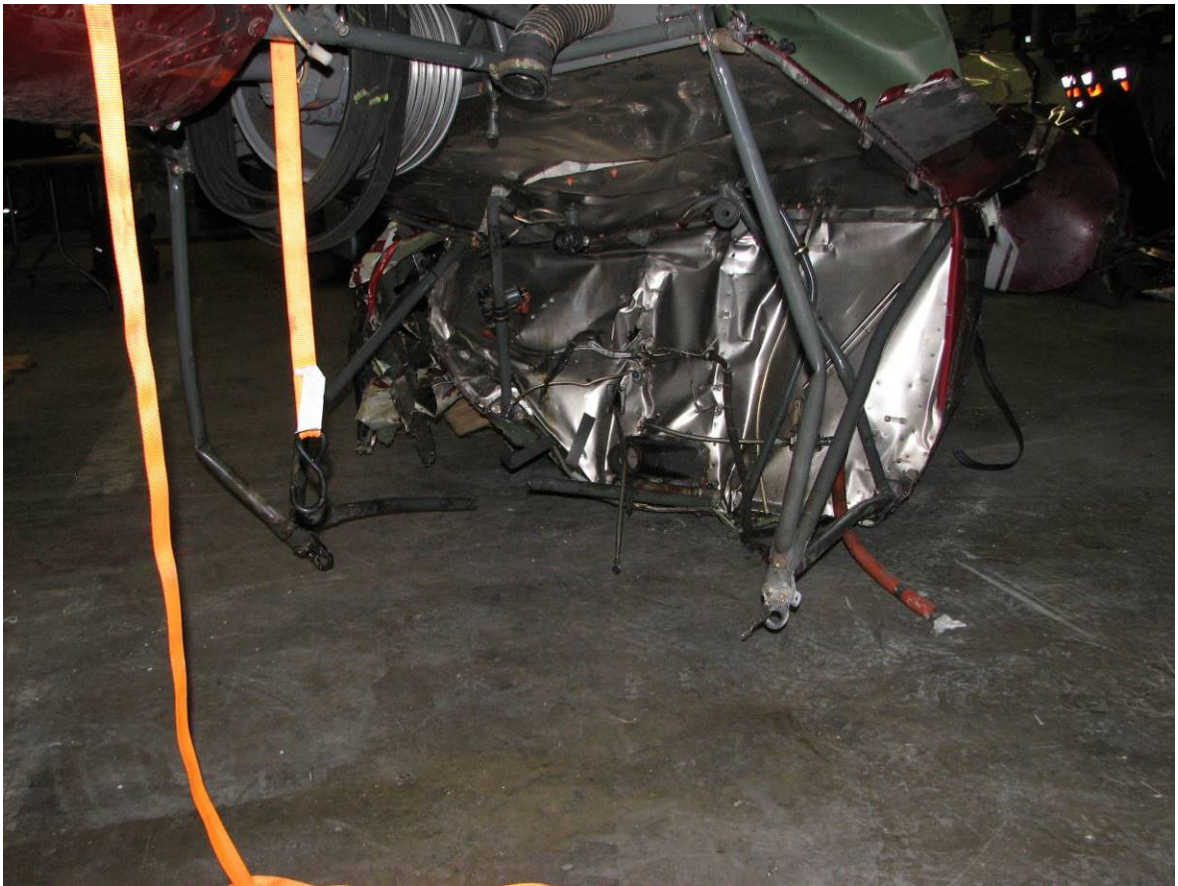
Damage to the vertical firewall

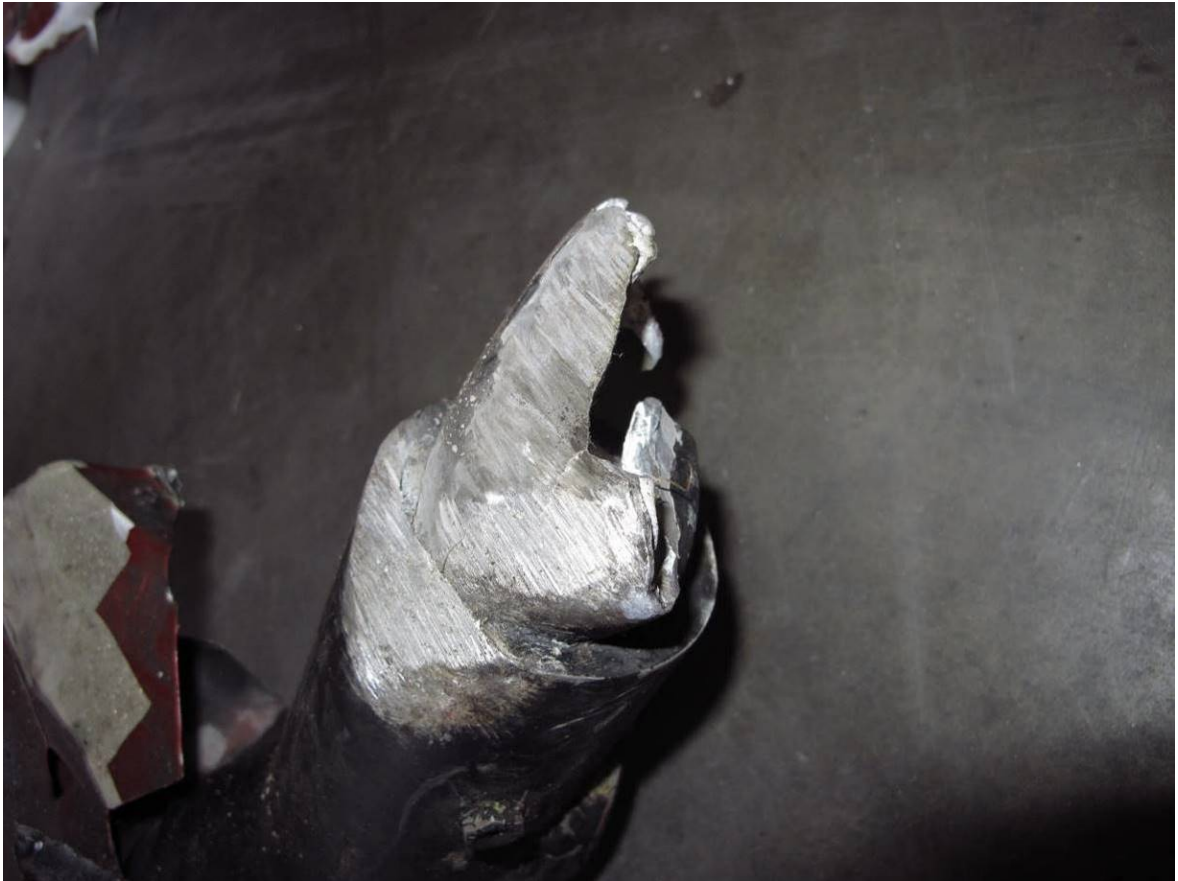
The aft cross tube was disconnected at the left elbow. The surface of the fracture was angular and jagged.

The fracture of the rear cross tube

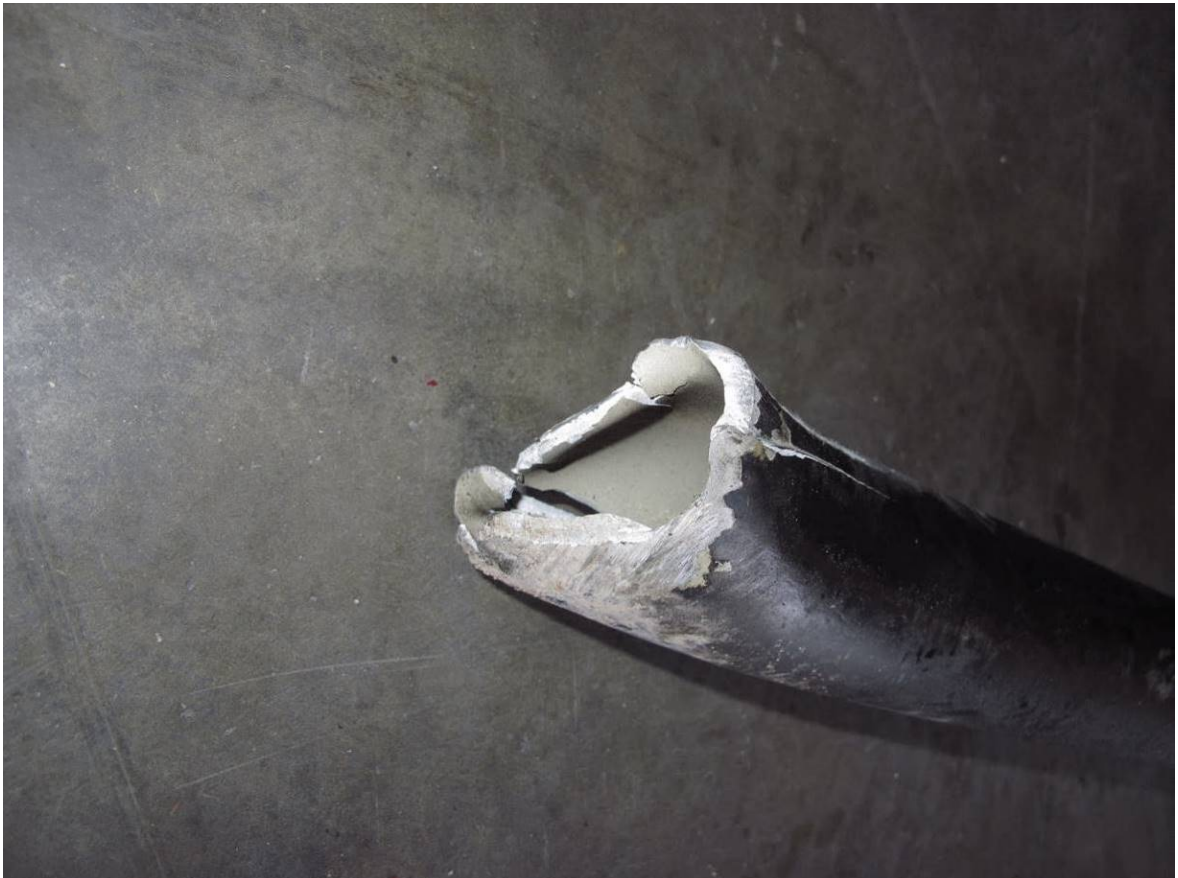
The fracture of the rear cross tube
